## THE XIV CONGRESS OF THE INTERNATIONAL ASSOCIATION FOR ENGINEERING GEOLOGY AND THE ENVIRONMENT

## Field Trip #2: Chengdu---Luding---Moxi---Chengdu

Topic: Two engineering masterpieces (Yakang Bridge and Luding hydropower station), one ancient iron chain bridge (Luding chain bridge is a famous red tourist attraction), two large-scale landslides induced by historical earthquakes (Wuzhisuo landslide and Mogangliang landslide) and one famous ancient town built on glacial water (glacier) deposit will be introduced.

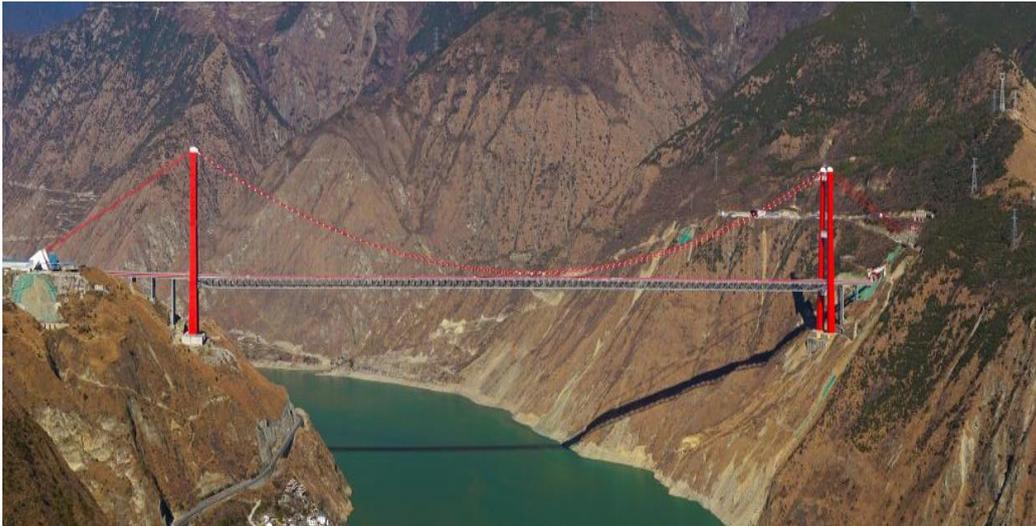
**Fig. 1 Overview of Yakang Bridge**

The Luding-Ya'an Bridge (Figs. 1&2) is a mega-span steel truss cable-stayed bridge that crosses the Dadu River Valley on the Ya'an-Kangding Expressway, and is known as the "No.1 Bridge in Sichuan and Tibet". Located in Zali Village, Luqiao Town, Luding County, the bridge is a key project and landmark building on the Ya'an-Kangding Expressway of State Route G4218 and has significant importance for the development of the Sichuan and Tibet regions.

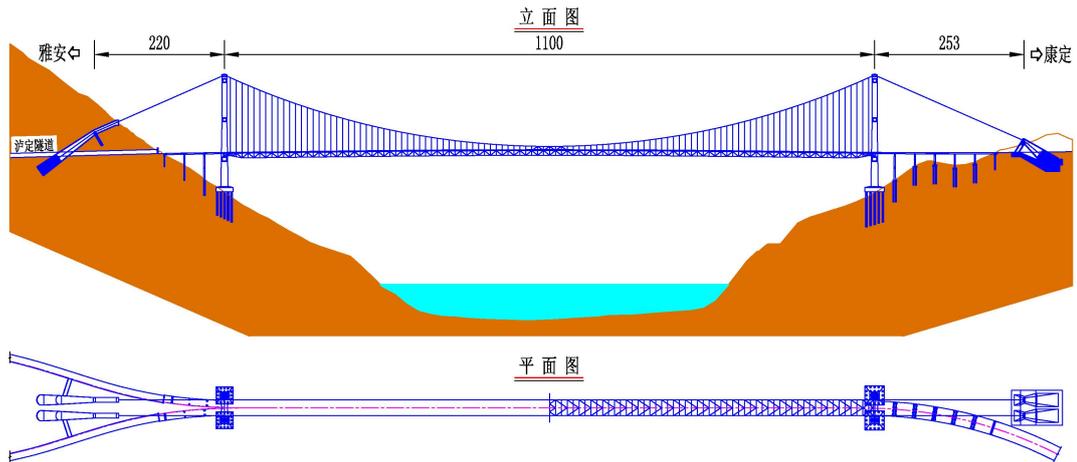
Fig. 3 Design and Elevation of Yakang Bridge

The bridge project consists of two approach bridges and the main bridge (Figs. 3&4). The main bridge is a 1,100m single-span suspension bridge, with a steel truss girder and a deck system composed of the steel-concrete composite structure. The main cables are made of 91 strands of prefabricated parallel wire ropes with a standard tensile strength of 1,860MPa and a 1/9 sag-to-span ratio. An articulated energy dissipation central clamp is installed at the mid-span. The anchorage system on the Ya'an side adopts tunnel anchors while that on the Kangding side uses gravity anchors. Both bridge towers are of portal frame type, with reinforced concrete columns, corrugated steel web plate composite beams, and group pile foundation. The two approach bridges are both continuous cast-in-place box beam bridges with a span of 34m (30m), and the total length of the bridge is 1,411.0m.

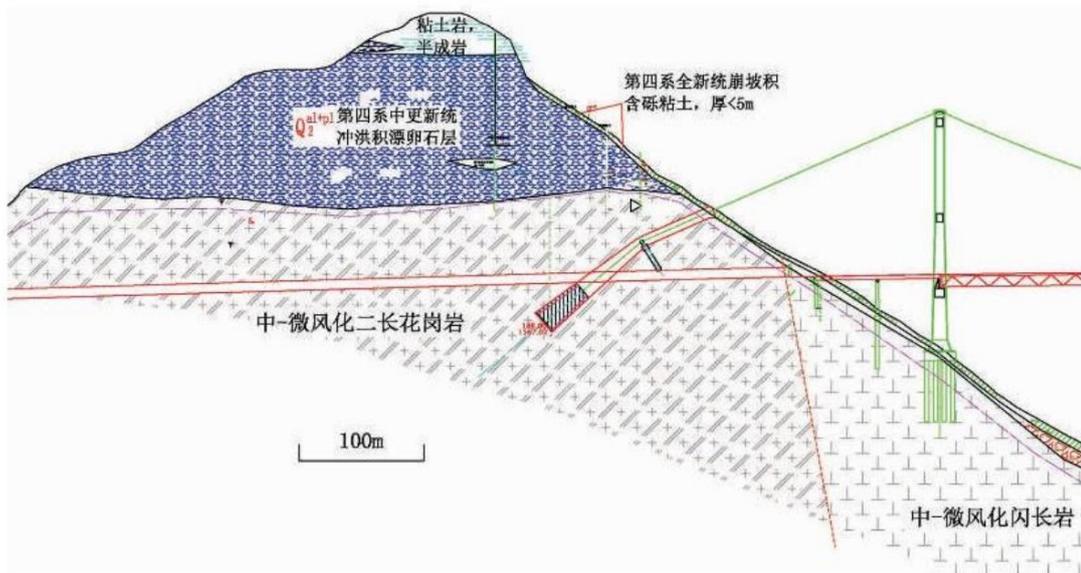
**Fig. 5 Typical Engineering Geological Profile on the Left Bank (ChengQ, 2014)**

The left bank is located on the concave slope formed by the U-shaped bend of the Dadu River, with a slope height of about 400m. A tunnel-type anchor is used, and the maximum height of the slope above the pier and anchor hole is still more than 200m. The long-term stability of the slope and the problem of debris flow hazards on the local slope surface of high altitude are prominent.

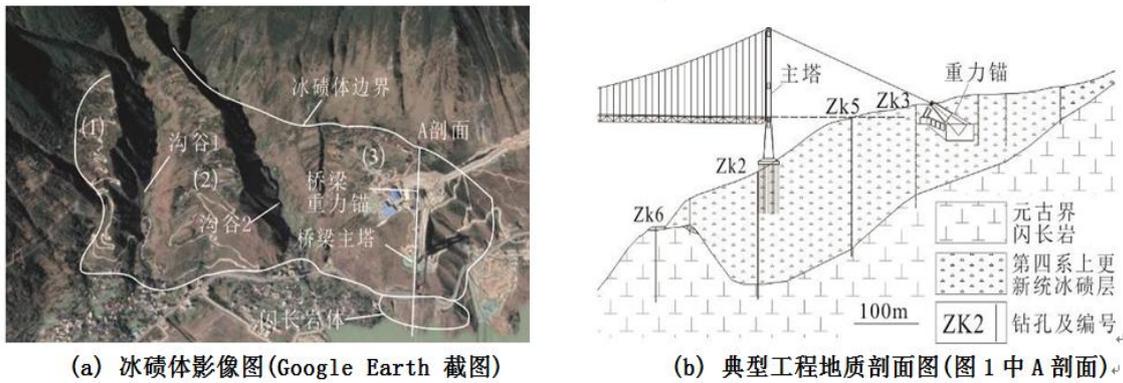
**Fig. 7 Distribution characteristics of moraine soil layer (a) and the typical geological profile on the right bank (b)**

The foundation of the main pier and gravity anchor on the right bank are located within a thick layer of glacial till. The thick layer of glacial till is used as the bearing layer, and there is no domestic or international

engineering precedent for this. After excavation, a soil foundation pit and slope with a maximum depth of approximately 82m were formed, which poses significant potential risks.

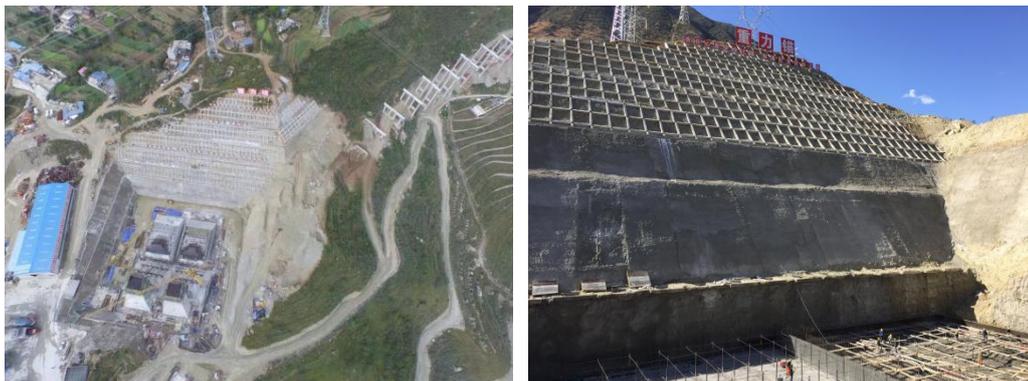
**Fig. 8 Construction of the Deep Foundation Pit for the Gravity Anchor**

Construction of the Deep Foundation Pit for the Gravity Anchor on the Kangding Bank, as shown in Fig. 8

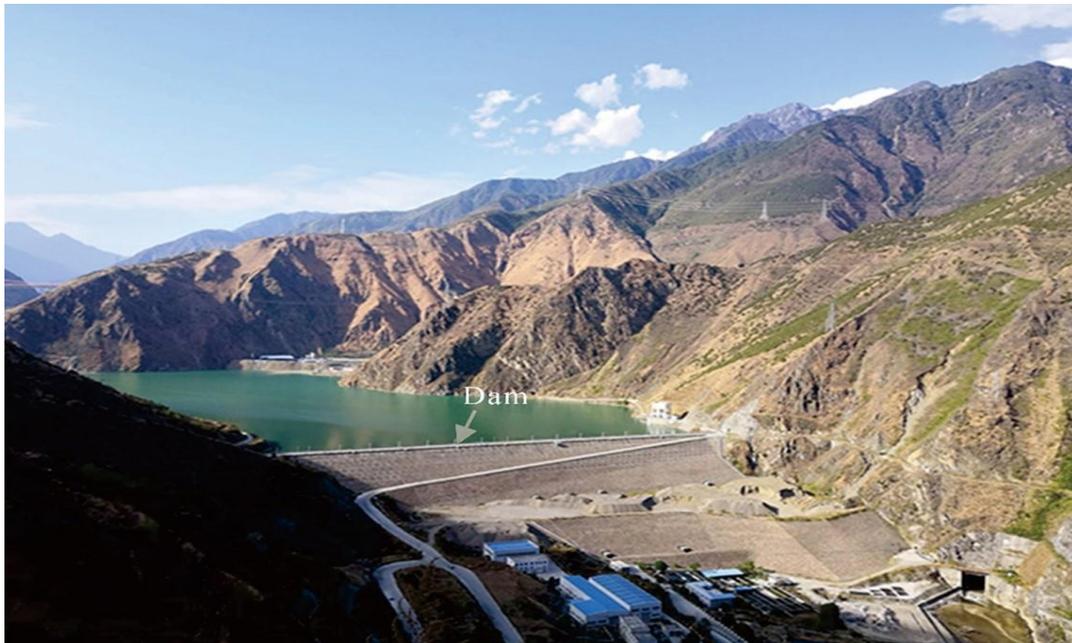
Fig. 1 Luding Hydropower Station

The Luding Hydropower Station (Figs. 1&2) is located in Luding County, Sichuan Province, China, approximately 2.5km from the county seat. The basic seismic intensity of the site is VIII, with a peak ground

acceleration of 0.3g. The installed capacity of the Luding Hydropower Station is 920MW, with a normal reservoir water level of 1,378.00m and a total storage capacity of 219.5 million m<sup>3</sup>. The dam of the Luding Hydropower Station is a rockfill dam with a crest width of approximately 12m, a maximum height of 84m, and a clay core wall for seepage control. The top width of the core wall is 4m, and the upstream and downstream slopes of the core wall and dam body are 1:0.25. The maximum bottom width is 45.00m, and an anti-filtration layer and transition layer are set between the core wall and the dam body.

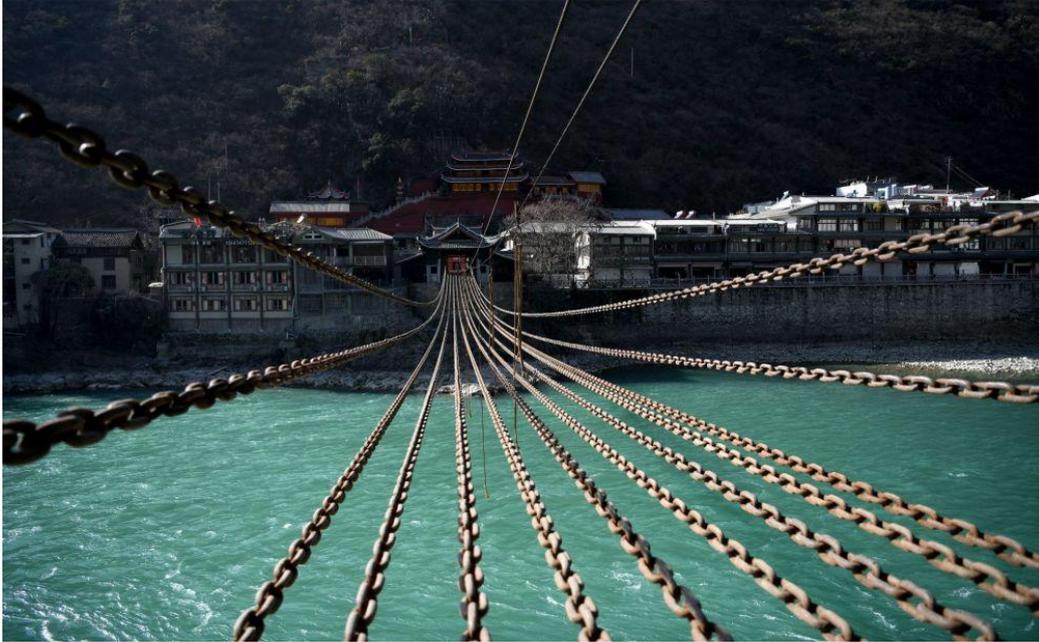
**Fig. 1 Luding Chain Bridge**

The Luding Bridge is a unique hanging iron chain bridge with wooden castle-like structures on either end. It consists of three main components: the bridge deck, bridge piers, and bridge pavilions. The total length of the bridge is 103.67 meters, with a width of 3 meters and 13 lock chains. Each side of the bridge has two iron chains for the railings, and the bridge deck has nine iron chains. Each iron chain is made up of 862 to 997 interlocking iron rings, for a total of 12,164 rings. The two bridge piers on either end are 20 meters high, with the east end of the bridge being 14.5 meters high and the west end being 5.2 meters high. The total weight of the bridge's iron components is over 40 tons, with the weight of the iron chains being 21 tons, averaging 1.6 tons per chain. A total of 20 tons of iron were used for one horizontal "lying dragon" pile and seven vertical "ground dragon" piles. Each wooden plank is 3 meters long and 0.1 meters wide, with the main walkway in the middle of the bridge being 0.75 meters wide and the auxiliary walkway at the railing being 0.2 meters wide.

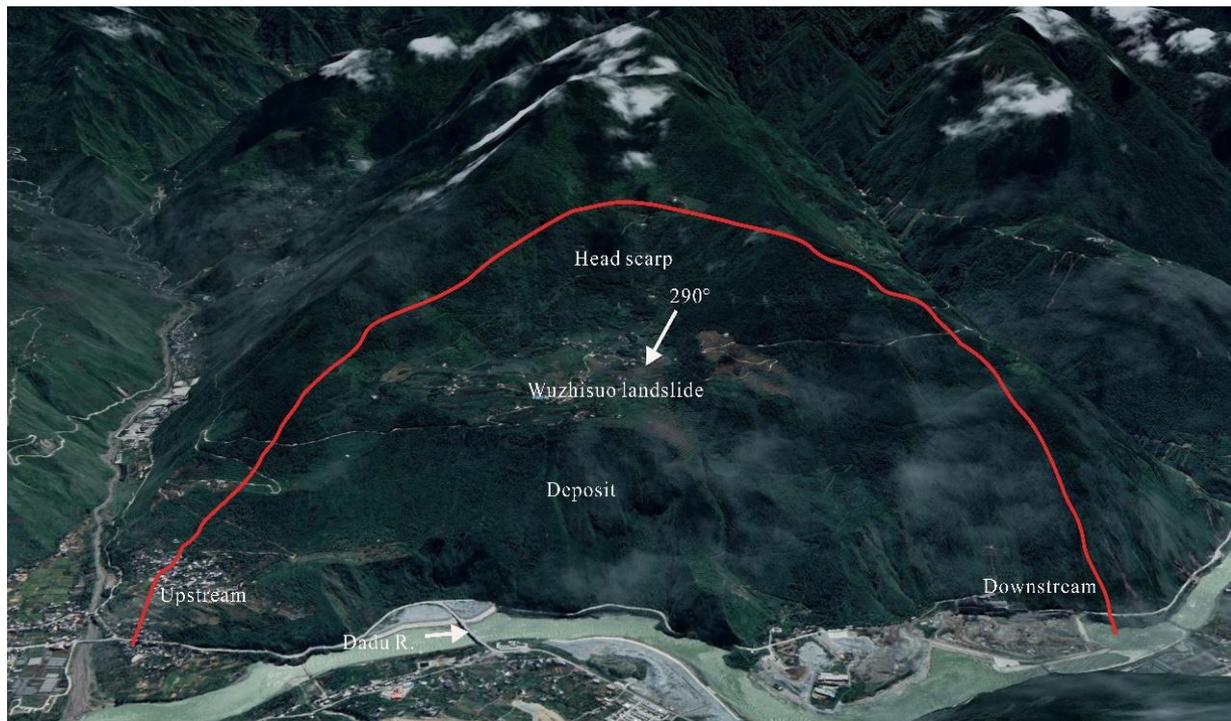
**Fig.1 Accumulation platform characteristics of Wuzhisuo landslide**

The landslide area is located at the intersection of northeast-southwest faults in Longmen Mountain. Wuzhisuo landslide is an ancient high slope earthquake landslide. The front edge elevation of the landslide is 1220 m, and the rear edge elevation is 1810 m. The landslide platform is clear, and the shape of the landslide area is like an armchair. The leading edge is cut by the Dadu River, leaving a  $60 \sim 70^\circ$  steep slope. The landslide is 1400 m long along the Dadu River, with an average width of 1300 m, an area of  $1.12 \text{ km}^2$ , an average thickness of 200 m, and a landslide volume of  $3.64 \times 10^8 \text{ m}^3$ . It is a large landslide. The main sliding direction is  $290^\circ$ . According to thermoluminescence dating, the landslide was formed 2.0-10<sup>4</sup> years ago.

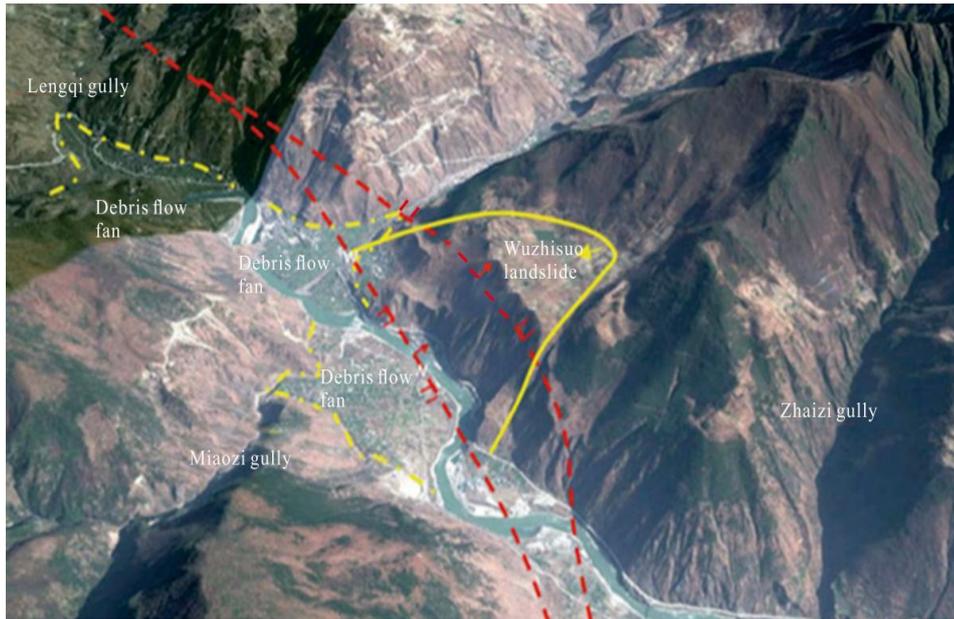
**Fig.2 Geological setting of Wuzhisuo landslide**

The bedrock of the landslide area is composed of Proterozoic diorite and granite. Due to the east-west tectonic compression and fault activity, the bedrock structural plane is developed. There is a large alluvial fan on the opposite bank (right bank) (Fig.2), which pushes the Dadu River to bend eastward.

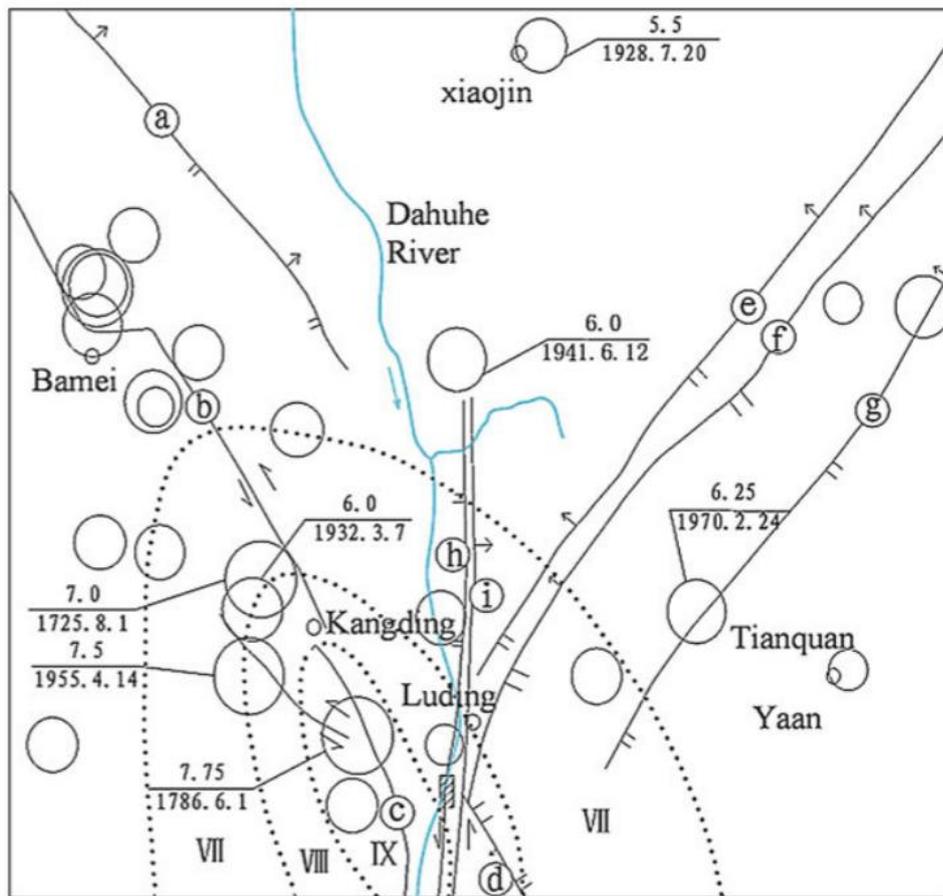
**Fig.3 The regional seismic-structure diagram**

Multiple faults are developed in this area (Fig.3), and the activity of Xianshuihe fault plays a major role in controlling regional tectonic stability. A series of earthquakes have occurred along the Xianshuihe fault. The seismic intensity is high, and the highest intensity recorded in history is VIII-X. The regional geostress reaches 20-25 MPa.

a Yuke fault; b Xianshuihe fault; c Moxi fault; d Jinping fault; e Gengda-Longdong fault; f Yanjing-Wulong

fault; g Dachuan-Shuangshi fault;h Guadagou fault,i Changchang fault; The rectangle with shadow: the landslide region

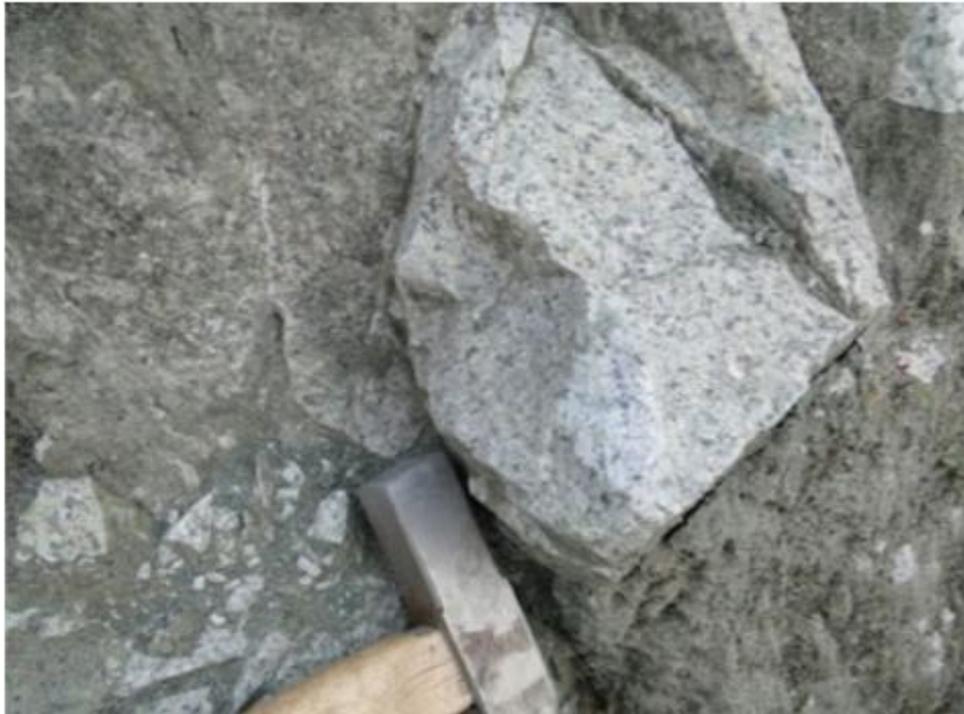
Fig.4 The huge blocks in the landslide accumulation

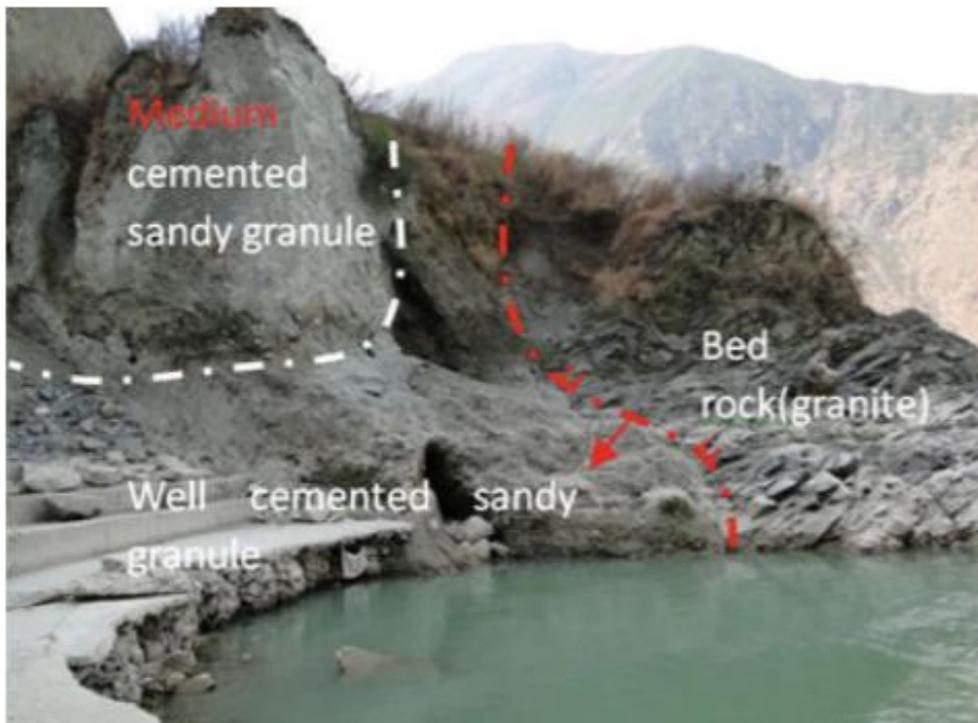
Fig.5 Medium cemented and well cemented sandy granule in the accumulation

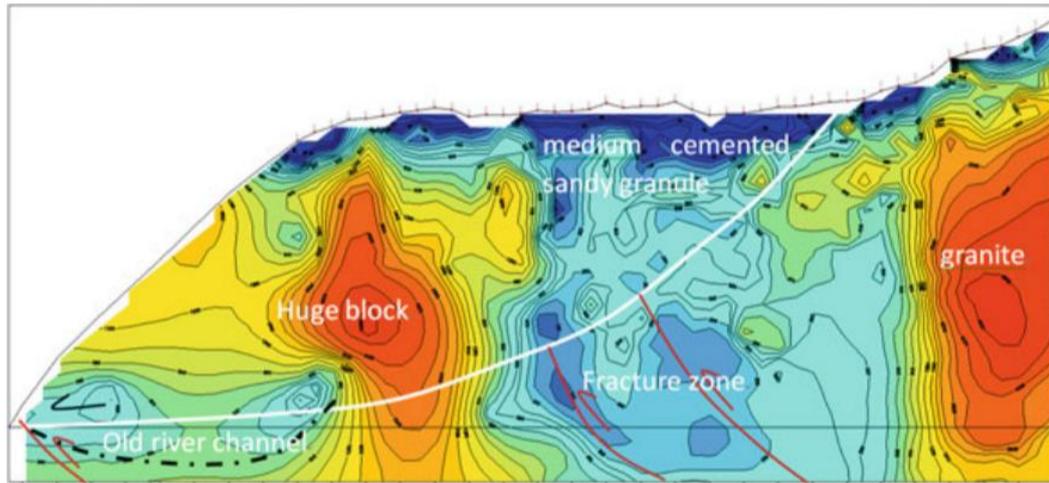
Fig.6 The geophysical prospecting interpretation (the white line represents the slipsurface)

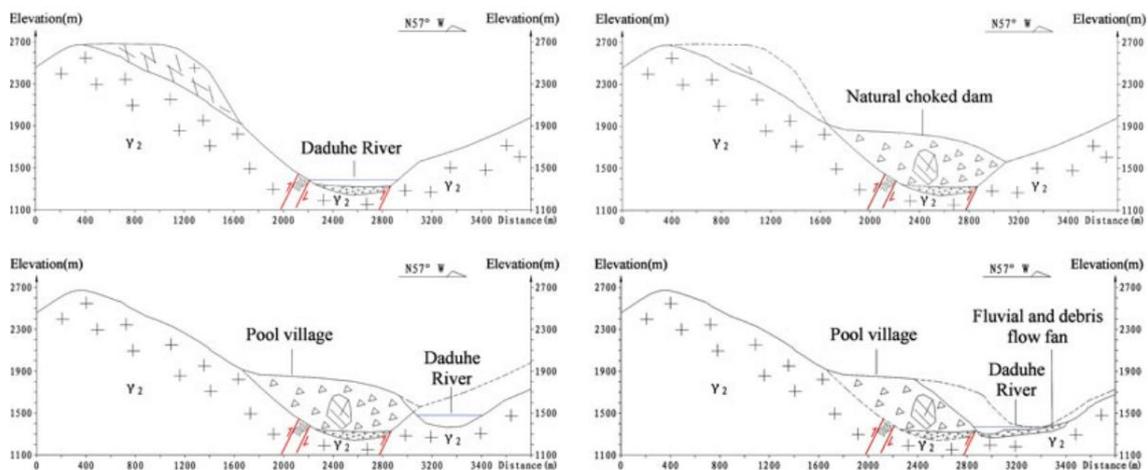
Fig.7 The evolution of the landslide

The evolution of the Wuzhisuo landslide mainly has four stages :the Wuzhisuo high slope with strong unloading is triggered by historical strong earthquakes, forming a large-scale landslide and blocking the Dadu River ;The Dadu River is filled with thick sediments, and the formed barrier dam is about 200 meters high and exists along both banks.The dam breaks along the right bank, cuts the slope and forms a new river channel ;Dadu River fault thrusts the landslide accumulation body ;The tributary debris flow happened and pushed the River channel bending earthward, the front was eroded and the landslide remains with steep front slope present. At present, the remains are generally stable, but the front is potentially unstable.Under the induction of certain factors ( earthquake, heavy rainfall, slope excavation ), landslides may still resurrect, blocking the Dadu River again, causing huge geological disasters.

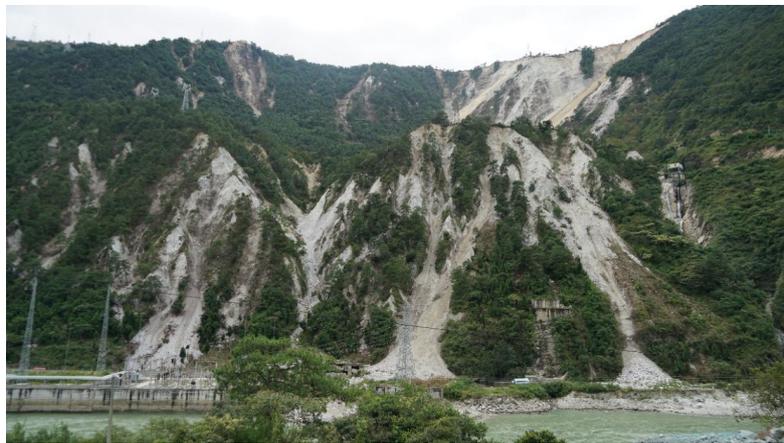
Fig 1 Characteristics of accumulation platform of Mogangling landslide

The Mogangling (MGL) landslide is located in the right bank of Dadu River and close to the mouth of Moxi River, it also near the Jinguang Village, Detuo Township, Luding County, Sichuan Province, China. This landslide was triggered by the Moxi Ms7.8 earthquake occurred in 1786, which blocked the Dadu River ~9 days until the dam-break. The size of the residual landslide deposit is ~450 m×1000 m (length×width) (Figure 1), with a volume about 4500×104 m3, and the sliding direction is N75°E. The elevations are ~1850 m in the back edge of the landslide source region, and 1110 m in the toe of the slope, respectively. It is worthy to note that there is a landslide platform with a dip angle of 5° ~ 10° located in the elevation between 1360 m and 1400 m.

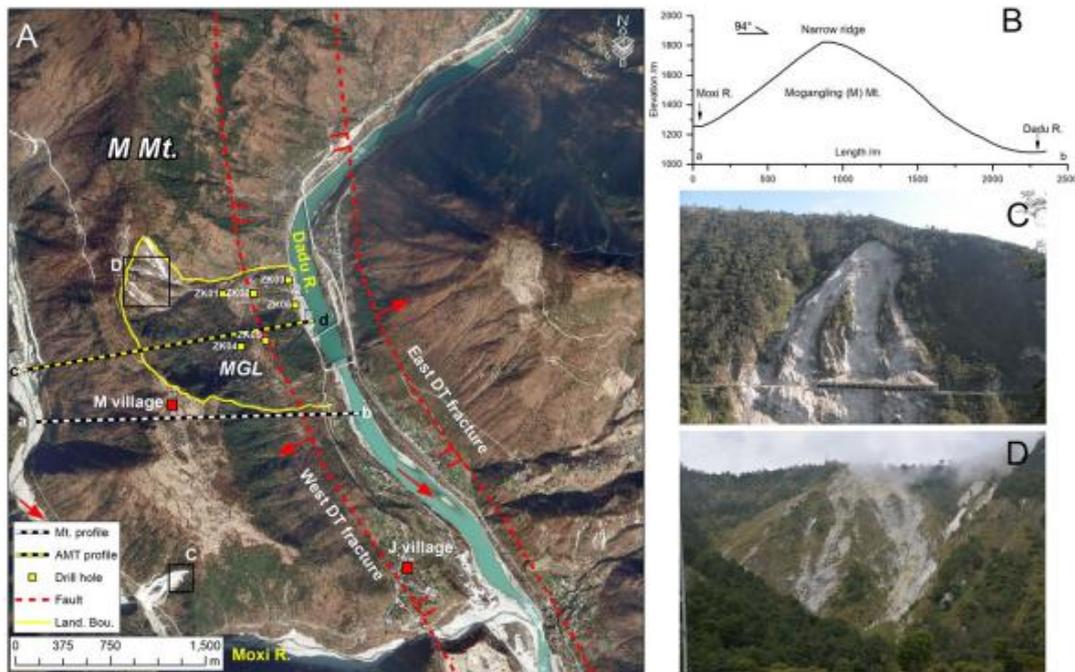
**Fig.3 Typical characteristics of M (Mogangling) mountain.**

A) Satellite image of Mogangling landslide, B) Profile of Mogangling mountain, C-D) field photographs of fractured rock at C point and D point. Geophysical prospecting profile (C-D) is shown in Fig.8. The satellite image is download from the software of Google earth.

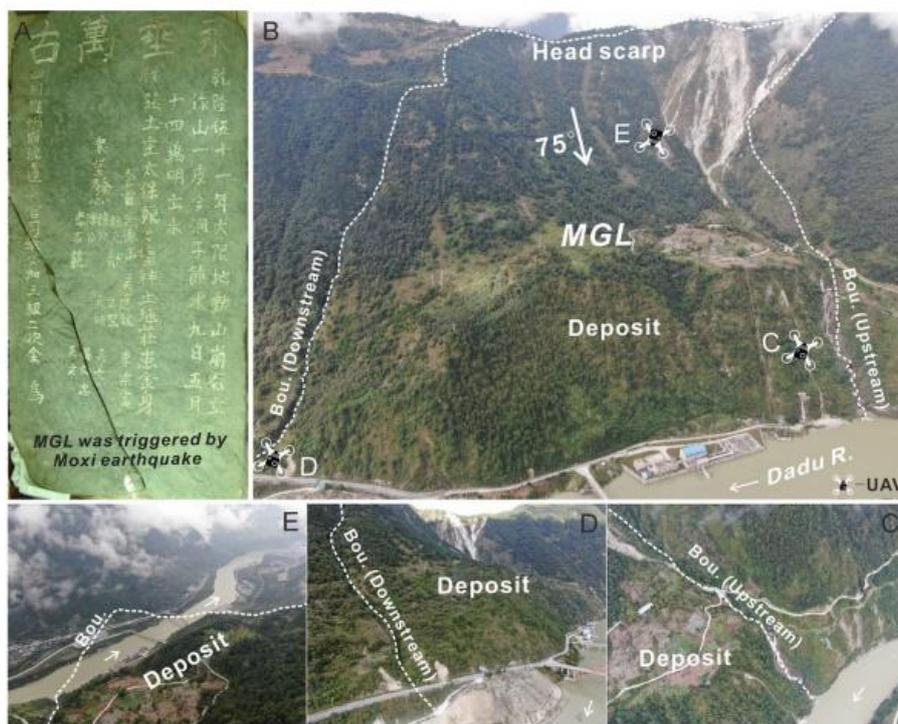
**Fig.4 Overall UAV images of MGL**

A) Moxi earthquake-triggered MGL recorded by ancient stele, B) Overall UAV images of MGL, C) Upstream boundary, D) Downstream boundary, E) Front edge of MGL

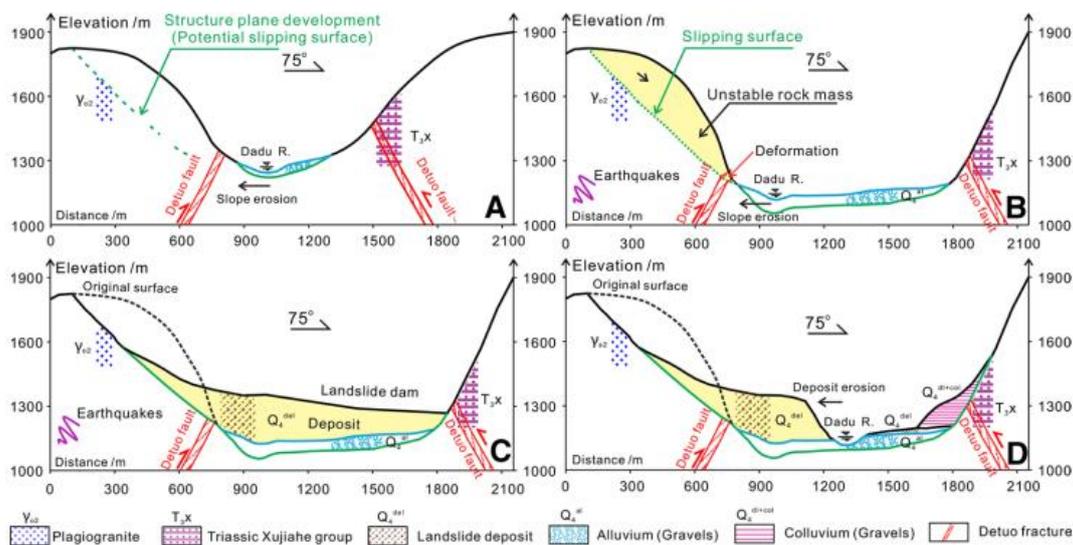
Fig.7 Failure process of MGL landslide.

It is recorded that an Ms7.8 earthquake occurred between Kangding and Moxi on June 1, 1786. The seismic intensity in the epicenter reached X degree, it also reached IX degree in the Mogangling landslide that close to the epicenter of this earthquake. This earthquake triggered the Mogangling landslide (Fig.7), and blocked the Dadu River ~9 days (Fig.8). Then, the landslide dam-break resulted in floods in the Leshan, Zhibin and Luzhou along the Dadu River, and caused more than 100,000 deaths. As far as we know, it may be the most catastrophic event due to the landslide dam-break in the world ever. Some works have been carried out to detect the location, magnitude, and intensive of the 1786 Kangding-Luding earthquake (Wang, 1987). In addition, Dai et al. (2005) attempt to research the Mogangling landslide dam-break by reconstructing the peak flow of the landslide dam, consulting historical documents, and investigating the local geomorphology. However, we still have a limited knowledge of the Mogangling landslide dam caused by this earthquake until present.

- a: Concave incision erodes slope foot continuously, b: Detuo fault deteriorated the slope stability further, c: MGL landslide was triggered by Moxi earthquake and blocked the Dadu River, d: long-term river erosion formed current topography

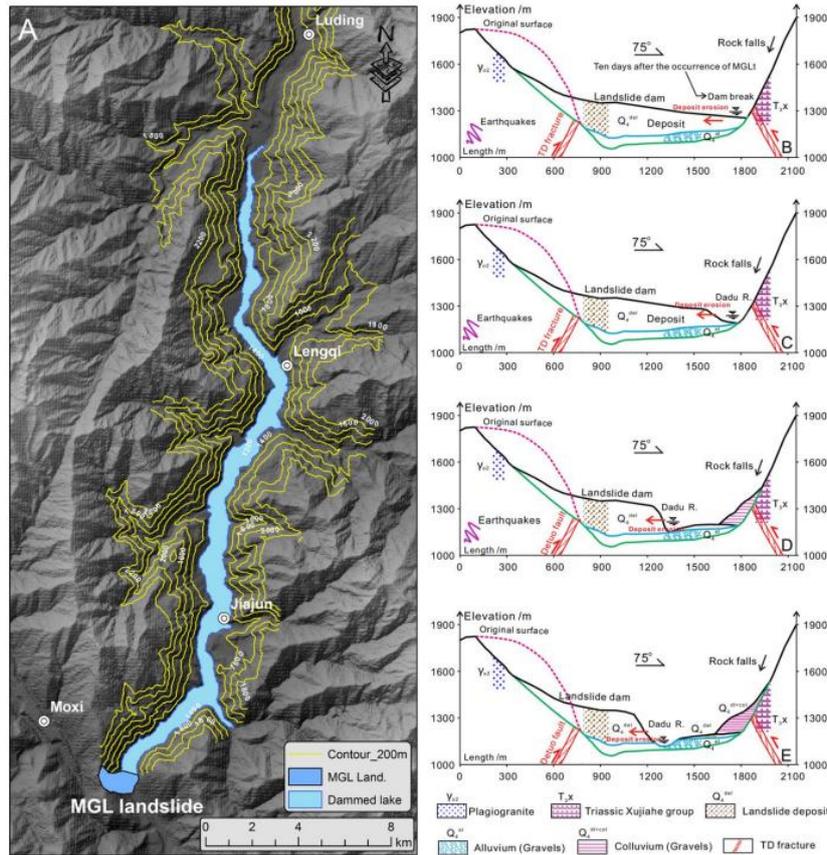
**Fig.8 Dam Lake and dam erosion evolution process.**

A) Dammed lake distribution after MGL landslide, B) Dam-break ten days after the occurrence of MGL landslide, C, D and E show the landslide dam erosion evolution process with time going.

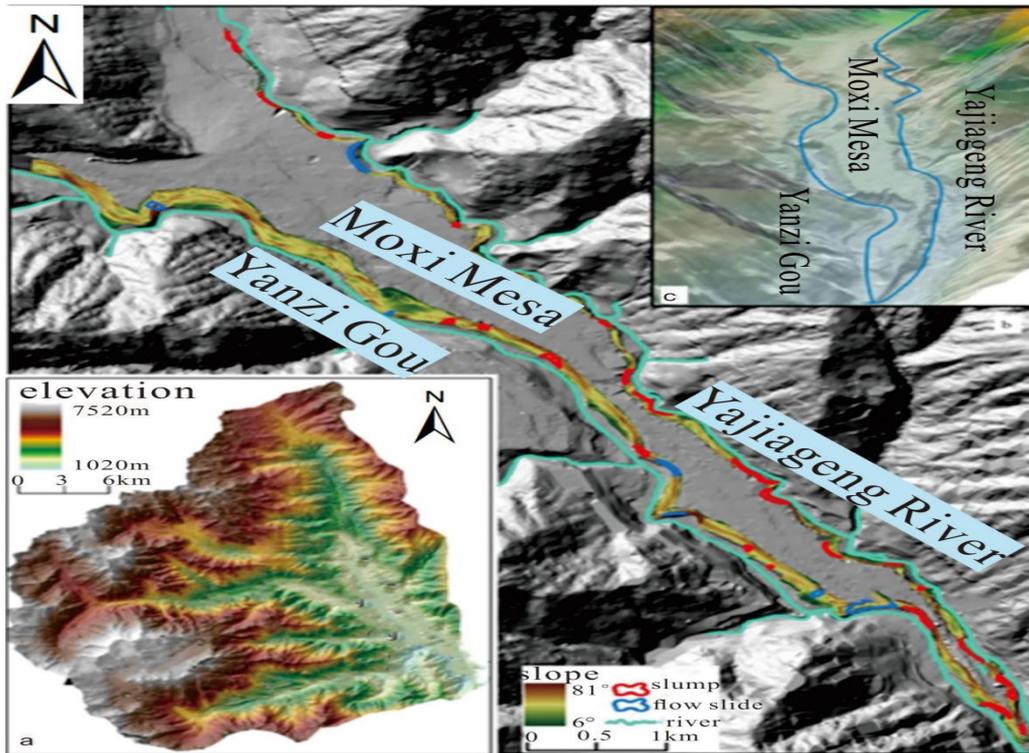
Fig.2 Distribution characteristics of landform and geological disasters in Moxi Mesa

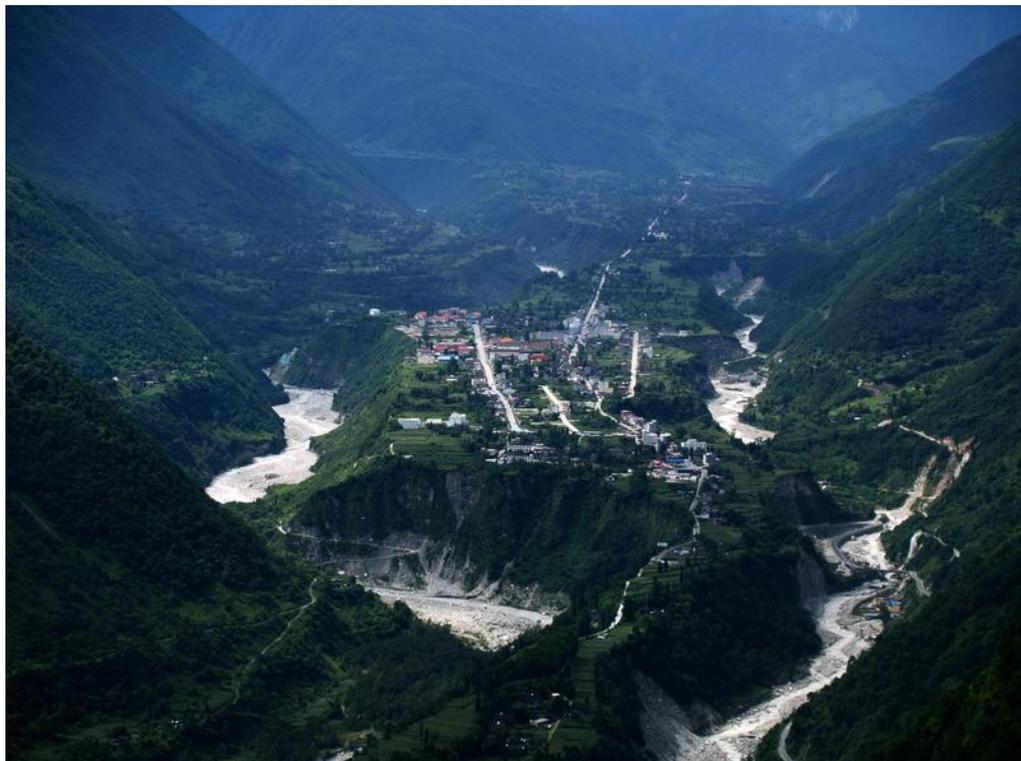
Fig. 3 Topography and geomorphic features of Moxi Mesa

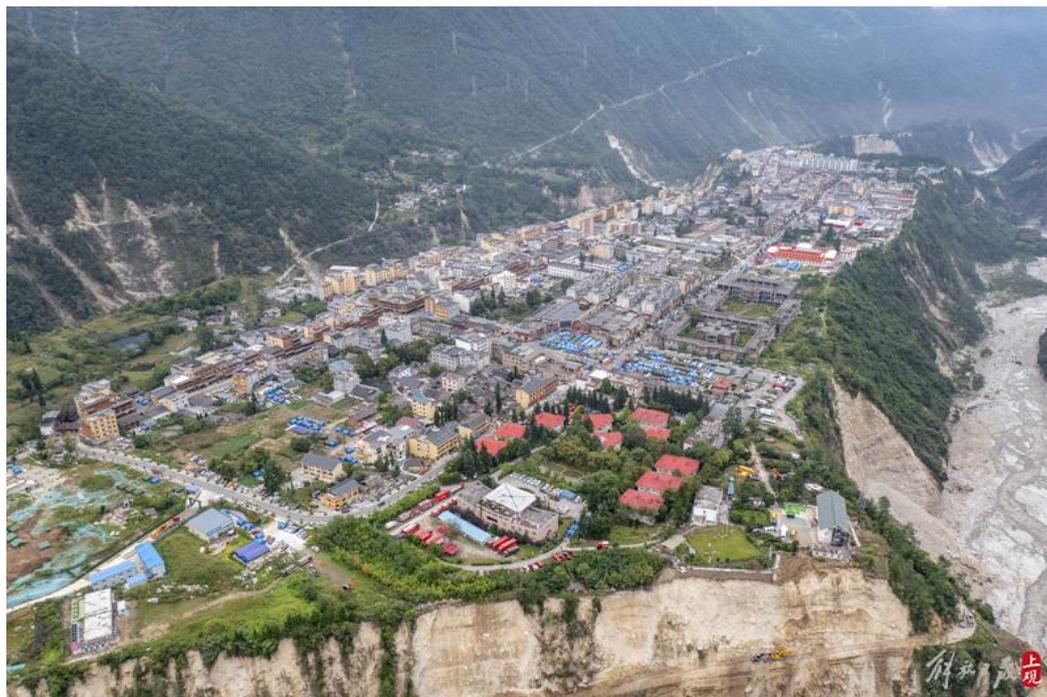
Fig.4 The collapse characteristics of Moxi Mesa edge after '9.5' Luding Ms 6.8 earthquake

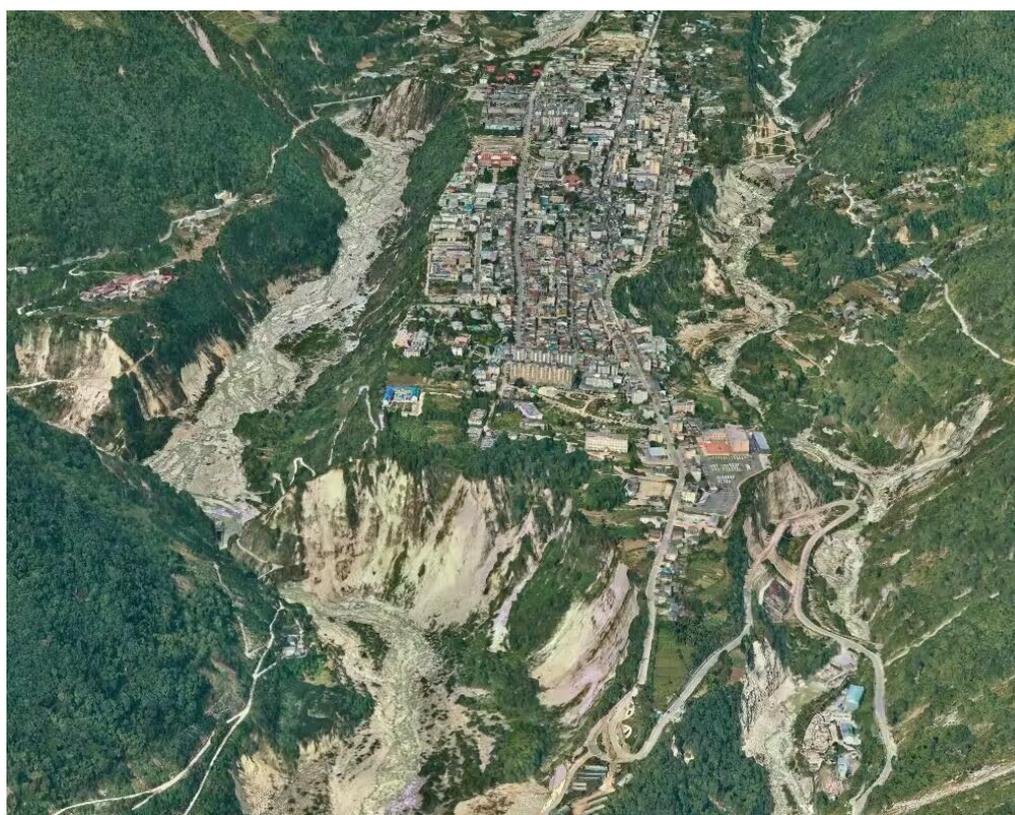
Fig.5 Distribution characteristics of geological disasters around Moxi platform after '9.5' Luding Ms 6.8 earthquake

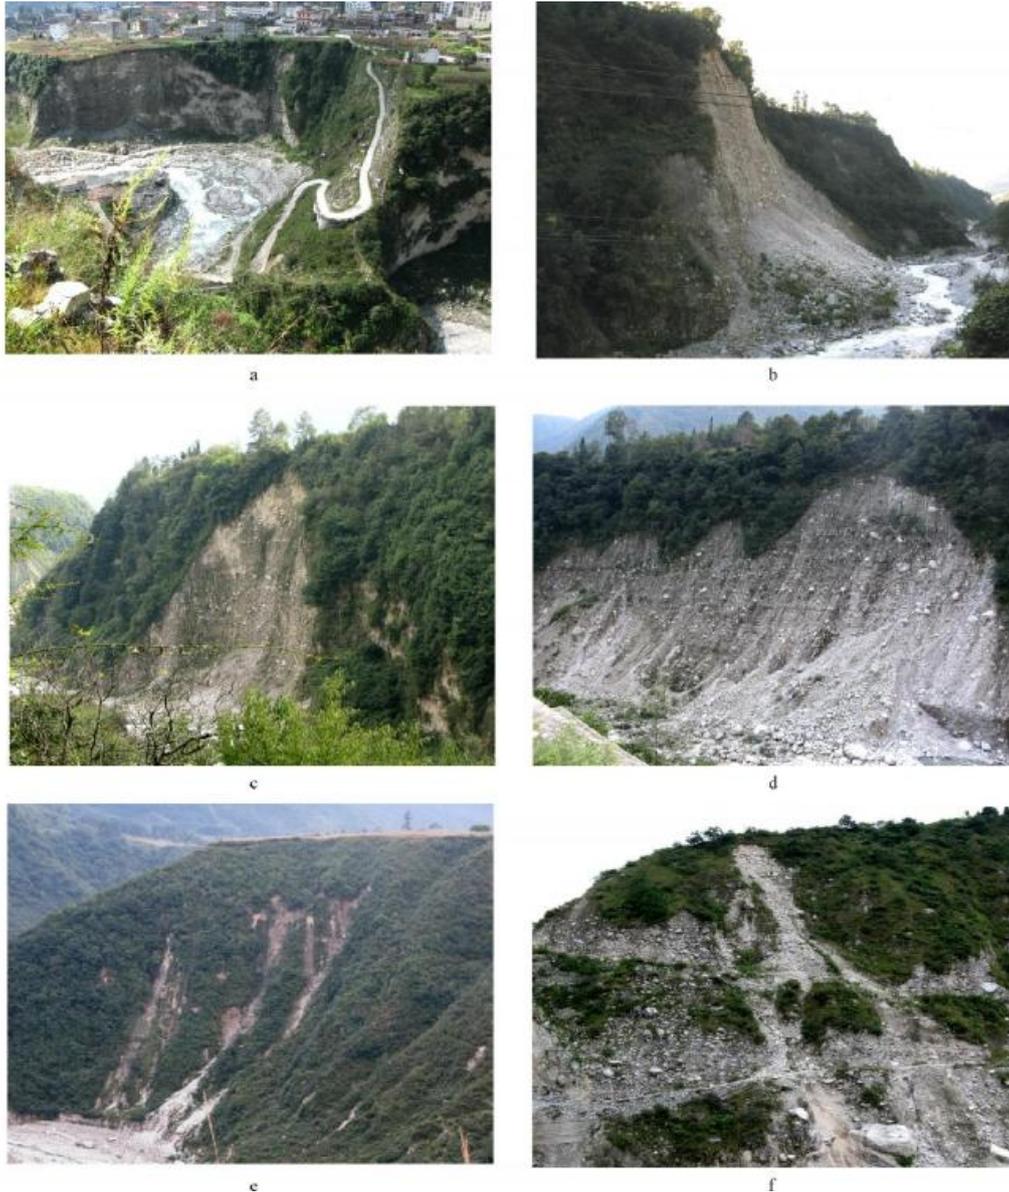
**Fig.6 Development characteristics of geological disasters around Moxi Mesa induced by '9.5' Luding Ms6.8 earthquake**

The Moxi Mesa is located in the eastern of the Gongga Mountain, where is the transitional zone between the Western Sichuan Plateau and the Sichuan Basin. It is found that the east, west and north of the Moxi Mesa are higher than its middle and the south part. In addition, the terrain is extremely changing in Moxi Mesa, and the highest elevation is 7520 m located in the Gongga mountain peak. The Moxi Mesa has a very complex geomorphic type including low mountain valley, high mountain, and extremely high mountain. Many faults including the Sichuan-Yunnan tectonic belt, Longmenshan fault-fold belt, Xianshuihe fault-fold belt, and the Jintang arc tectonic belt had been developed in this area, which caused that multi-stage tectonic movements in this area since the early Proterozoic. Moreover, the Moxi Mesa is composed of glacial deposits, underlying granite, diorite, and limestone. And the epicenter of the '9.5' Luding Ms 6.8 earthquake is located in the Moxi fault belt southeast of the Mesa.

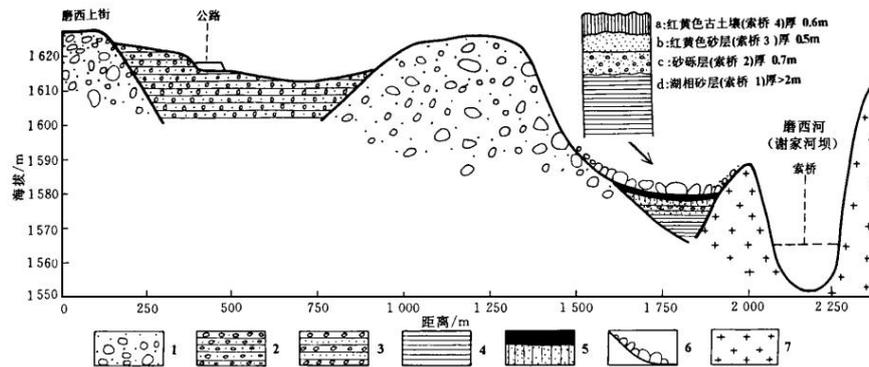
**Fig.7 Quaternary glacial, glacial-lacustrine sedimentary profiles in the eastern Moxi Mesa, Luding County.**
